Manhole Inspection Summary

Manhole # S41U__027MH

Insp Date: **3/6/08 10:47 AM**

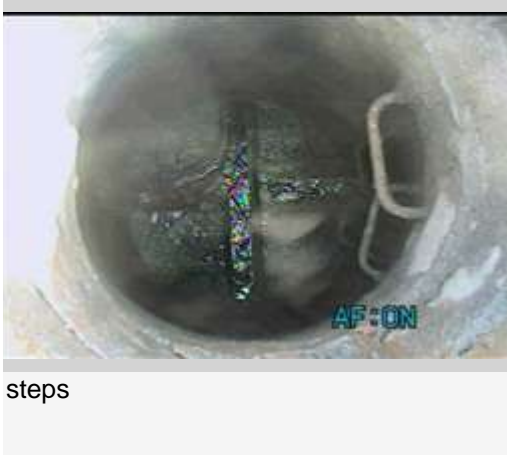
Defect 1

Count: **6** Missing: **0** ☒ **Corroded**

steps

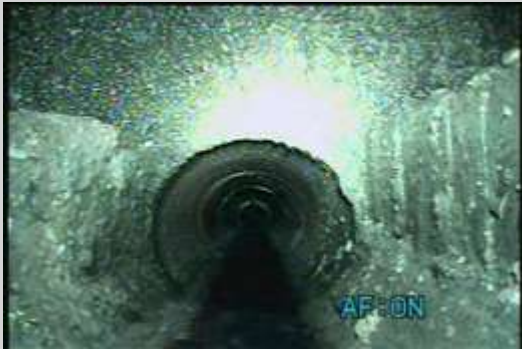
12 O'Clock Outflow

8 in. Circular Gravity Sewer
Pipe Out @ 12 O'Clock

Pipe Material: **Clay** ☐ Pipe Lined

Invert Depth: **10.70** (ft.) Flow Characteristics: **Fast**

Deposits: ☒ None ☐ Mud ☐ Sludge ☐ Debris ☐ Grease

Infiltration: **None** Pipe Seal Cond: **Unknown**

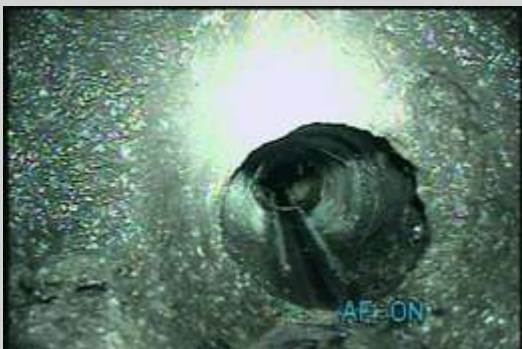
3 O'Clock Inflow

8 in. Circular Gravity Sewer
Pipe In @ 3 O'Clock

Pipe Material: **Clay** ☐ Pipe Lined

Invert Depth: **10.00** (ft.) Flow Characteristics: **None**

Deposits: ☒ None ☐ Mud ☐ Sludge ☐ Debris ☐ Grease

Infiltration: **None** Pipe Seal Cond: **Unknown**

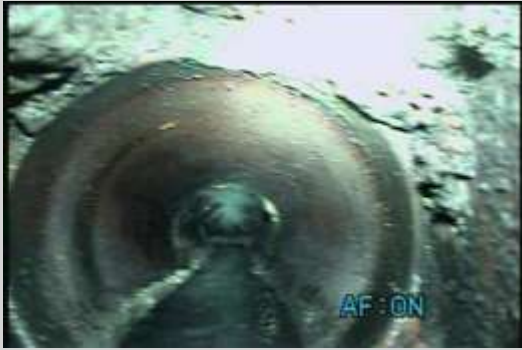
6 O'Clock Inflow

8 in. Circular Gravity Sewer

Pipe In @ 6 O'Clock

Pipe Material: **Clay** ☐ Pipe Lined

Invert Depth: **10.70** (ft.) Flow Characteristics: **Fast**

Deposits: ☒ None ☐ Mud ☐ Sludge ☐ Debris ☐ Grease

Infiltration: **None** Pipe Seal Cond: **Unknown**

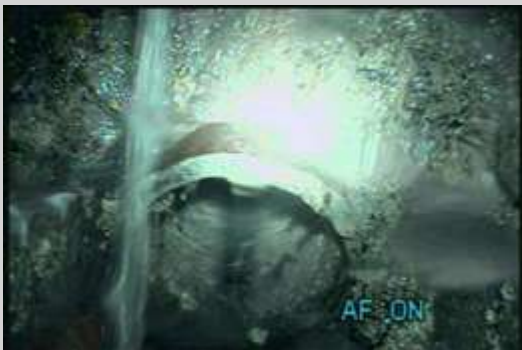
9 O'Clock Inflow

8 in. Circular Gravity Sewer

Pipe In @ 9 O'Clock

Pipe Material: **Clay** ☐ Pipe Lined

Invert Depth: **10.70** (ft.) Flow Characteristics: **Fast**

Deposits: ☒ None ☐ Mud ☐ Sludge ☐ Debris ☐ Grease

Infiltration: **None** Pipe Seal Cond: **Unknown**
